**DEVELOPMENT OF A FRAME WORK FOR PREMATURE FAILURE ANALYSIS OF
SUSPENSION SYSTEM UNDER POOR OPERATING CONDITION**

KEYWORDS: Suspension system, premature failure, poor operating condition, survey sheet

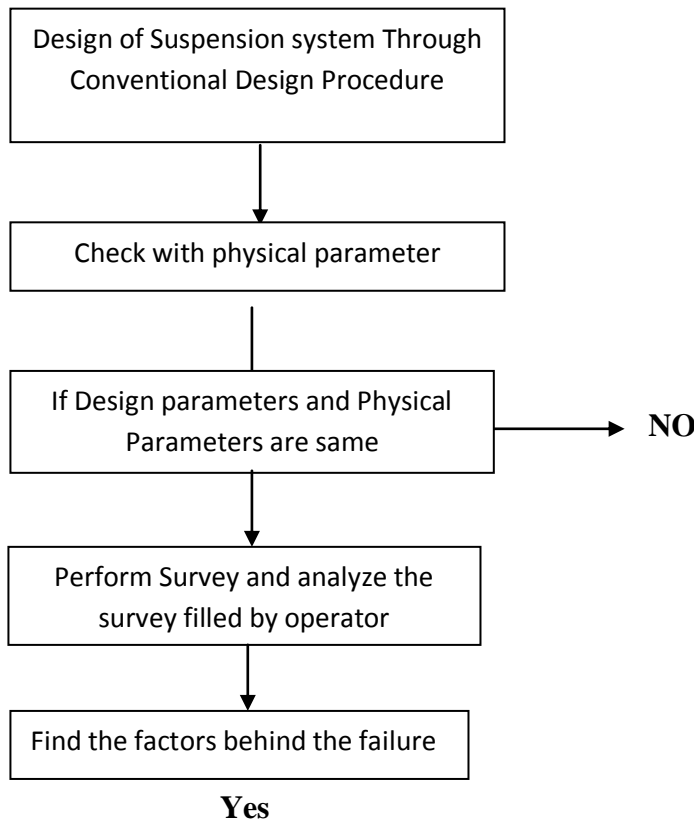
FIGURE: 1 FLOW CHART OF SUSPENSION SYSTEM FAILURE ANALYSIS

Fig. 1 is flow chart which shows the step by step procedure to perform the premature failure analysis. One may start analysis from doing the design of suspension system. In most of the case design are safe. So it may be a last step also. It has been observed that in many cases it has been observed that poor design or manufacturing defects are not behind the premature failure analysis. So premature failure may

be attributed to the poor operating condition. To confirm it a survey sheet has been developed which will be useful in such condition.

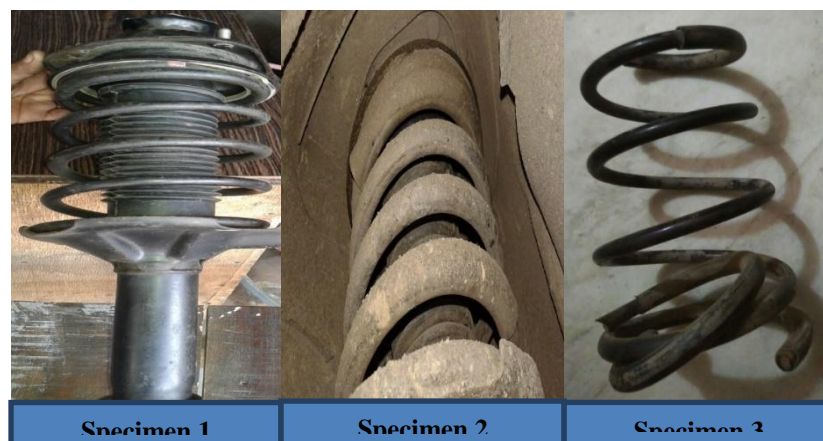
Figure2: Specimens of Coil Spring

For the failure analysis purpose specimens are procured from service centers of Tata Motors situated at different locations. Three specimen are shown in Fig. 2.

By observing the data presented in the table.2 it appears that all three specimens are as per design. So, the poor design of suspension spring is not the reason behind premature failure of these springs.

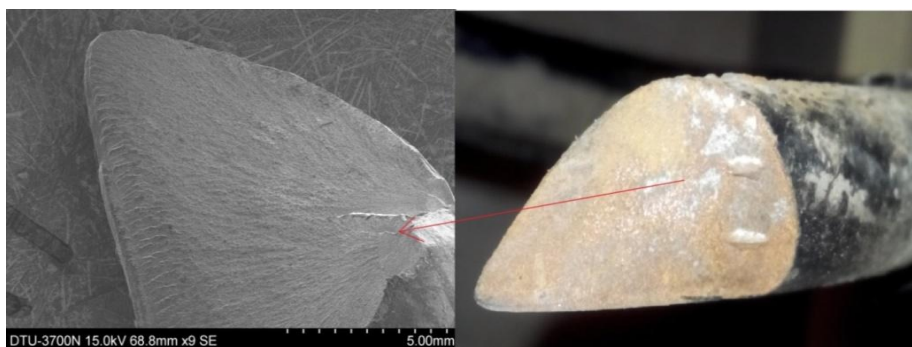
Figure3: Broken Coil Spring

Suspension coil spring is manufactured through cold drawing process which required ductility. In the figure two images are shown; first capture by SEM and second real image. In the figure, fracture in part is developed due to localized stress. Change in the geometry of spring in operating conditions, Due to this geometry change and localized stress introduces stress concentration at a point on second coil or first active coil from kurb in suspension spring. Due to higher stress at a point in spring under dynamic loading condition, crack formation initiated and growth of crack takes place. Consequently, after some time, failure of coil spring takes place.

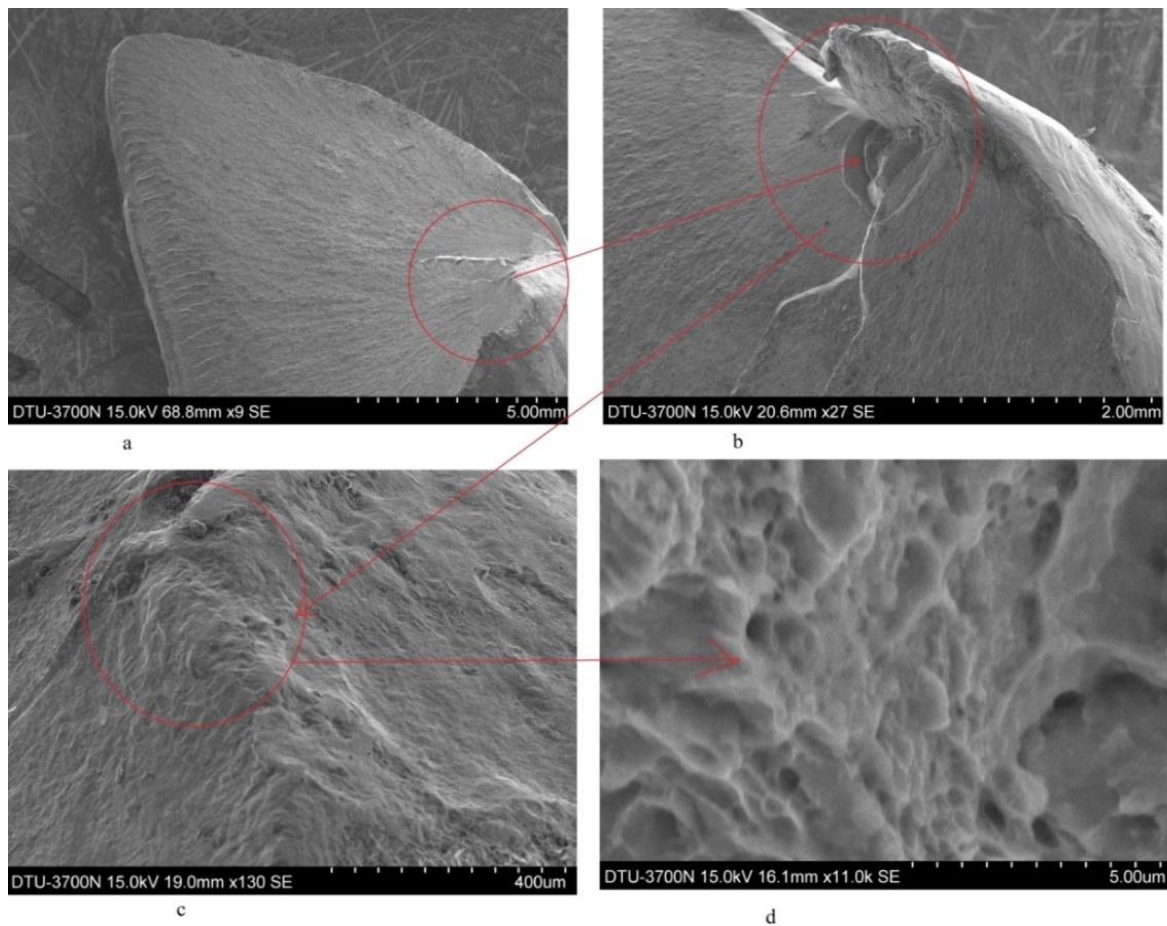
FIGURE 4: SURFACE IMPERFECTIONS IN COIL SPRING

The fracture part of helical spring is investigating through SEM analysis Spectro max for SEM analysis where at from fracture helical spring and polished using standard metallographic technique and etched with glyceria (30 ml dilute solution of HCl, 15ml HNO₃ and 45ml glycerol). SEM evaluation was come out on the fracture surface of coil spring the failed spring was cut from for SEM study its fracture reason.

The figure 8 shows surface imperfection in suspension coil spring, in the figure 'a' 5mm optical zoom the surface of fracture area was not proper some cold particle is presented this fracture reason, in figure 'b' increased zoom to show the better fracture condition to shows fracture area the crack recognized slowly and after some time suddenly break due to holes find out in the figure 'c' shows easily as well as in figure 'd' shows. So, the surface imperfections can produce to some hardness in material to make crack, tool marks, surface impurities due to the raw material, scale embedded of base material during cold drawing. Two different surface defect holes sufficient to cause fails coil spring in figure 15 (c) and the second figure 15 (d) surface defects are inherited in the raw material.

So specimen-1&2 failed due to defects in materials. For analysis did not revealed the reason of failure of third specimen.
